NOVEMBER 13, 2023

RE: POST-FIRE EVALUATION: SUPPLEMENTAL LETTER: COLLINS RESIDENCE, VFES OK-04.28.2021.01: 1312 WEST 60TH STREET NORTH, MUSKOGEE, OKLAHOMA:

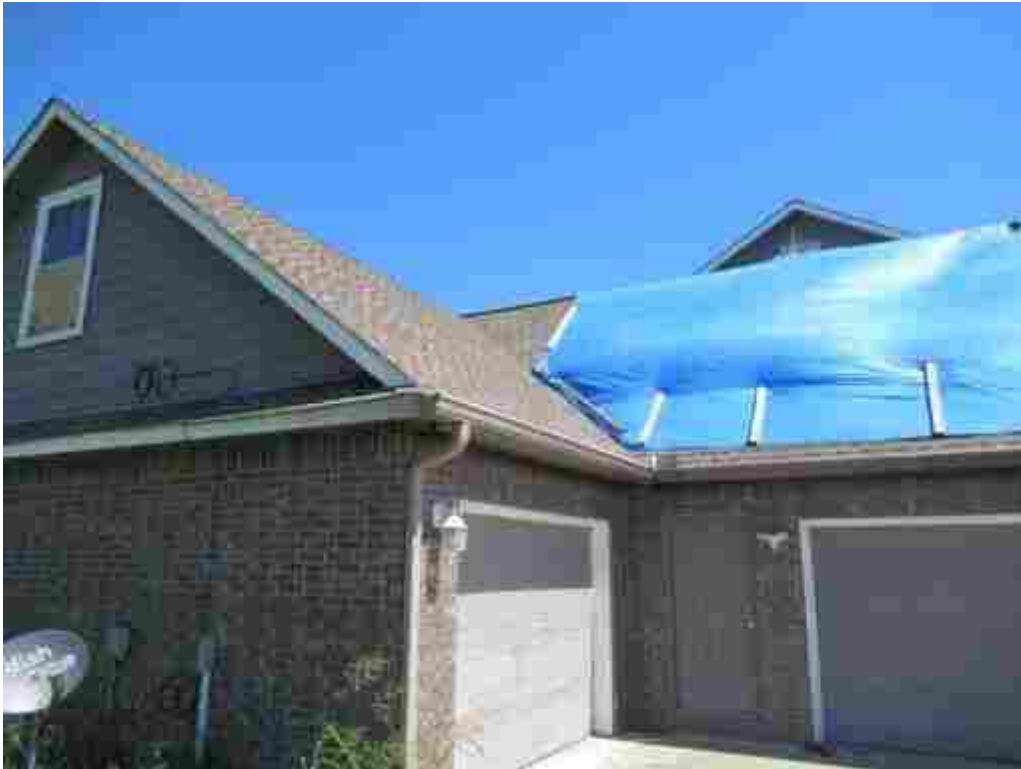
The tarp installed over the double garage with the partially boarded window of the Theater Room.

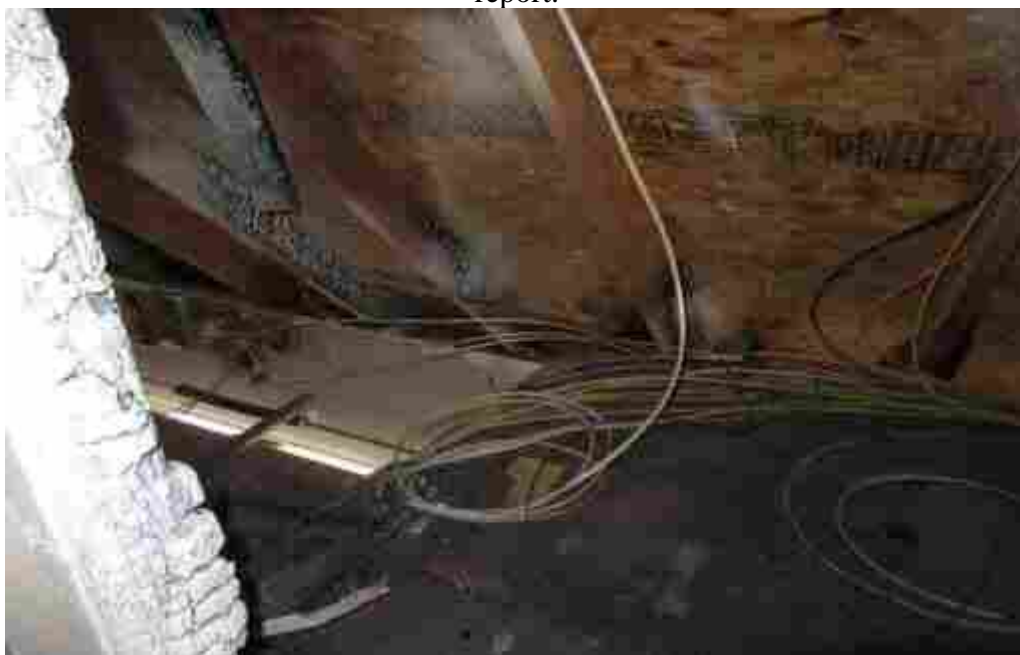
The roofs decking has been replaced but partially charred rafters remain.

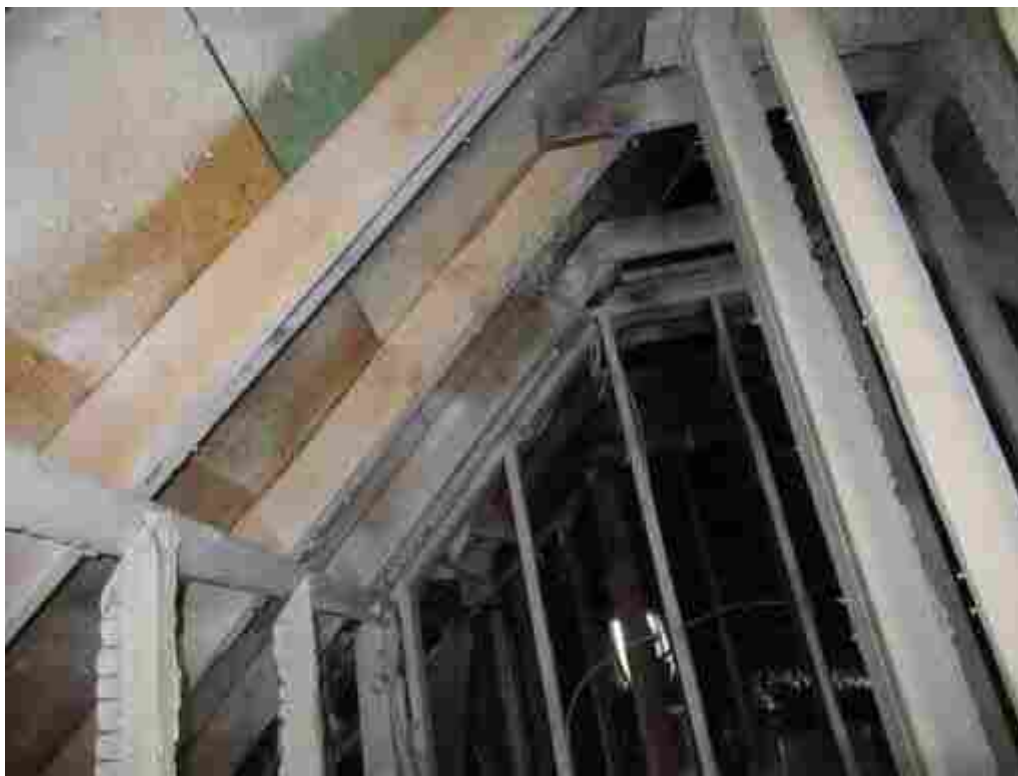
This area, above the origin of the fire, shows new decking and new rafters attached against the fire damaged rafters. An odor sealer has been applied to the old framing members.

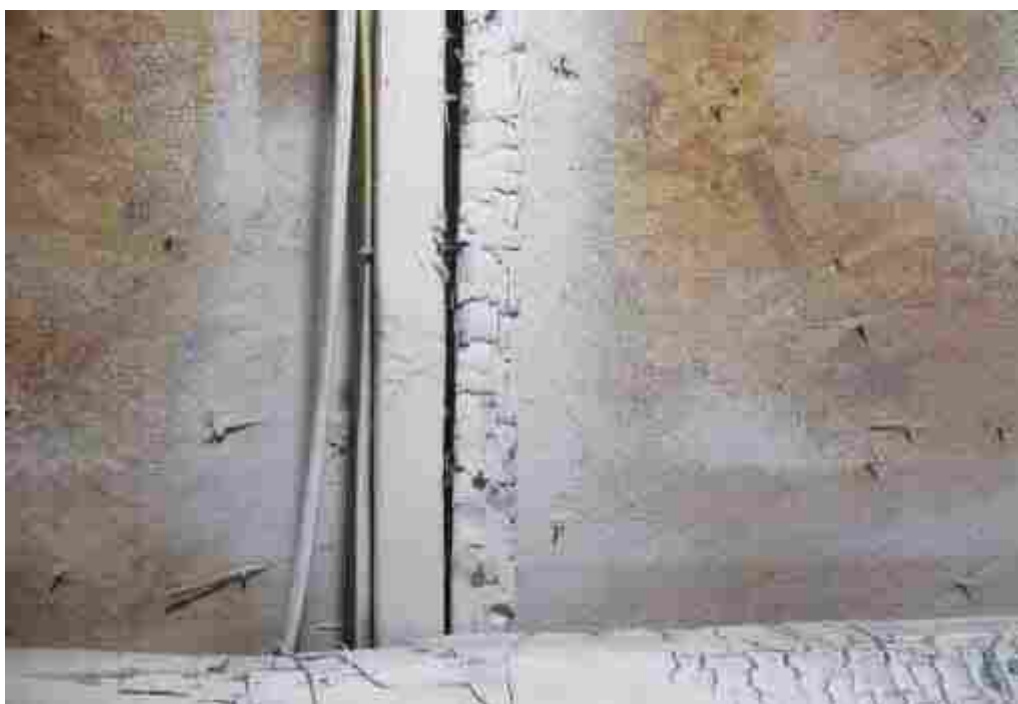
A fire damaged rafter with a new sister rafter. Both have been sealed.

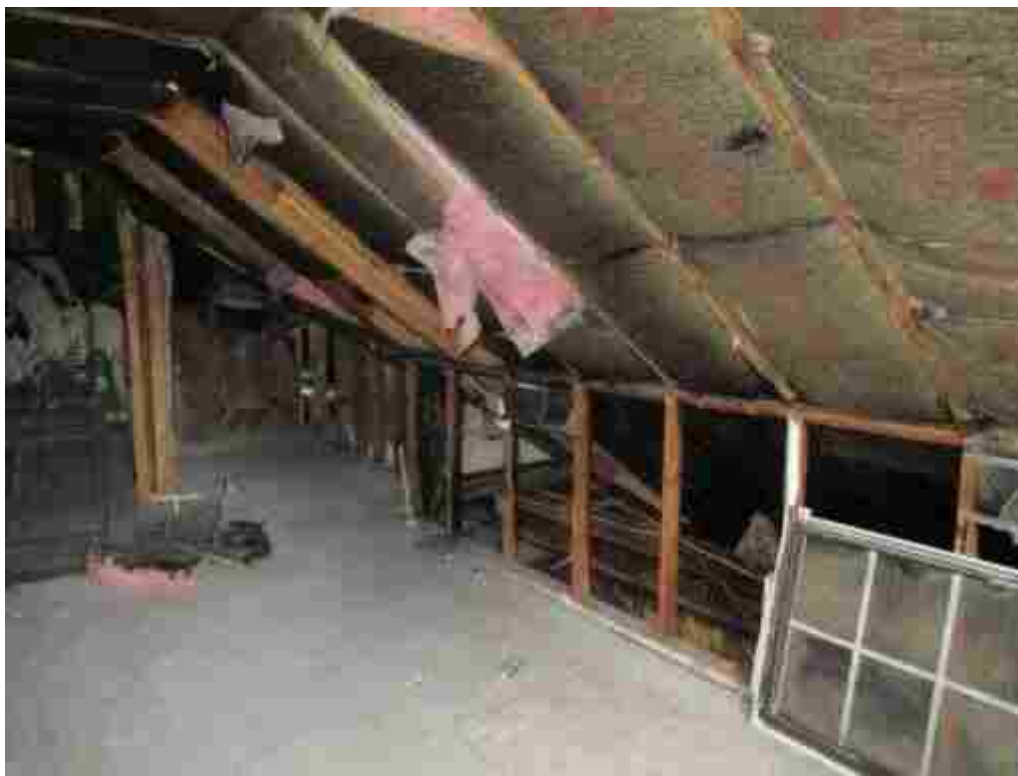
The south wall of the Theater Room. The finishes have been removed but the framing was not replaced despite a new roof being installed above this section of the house.

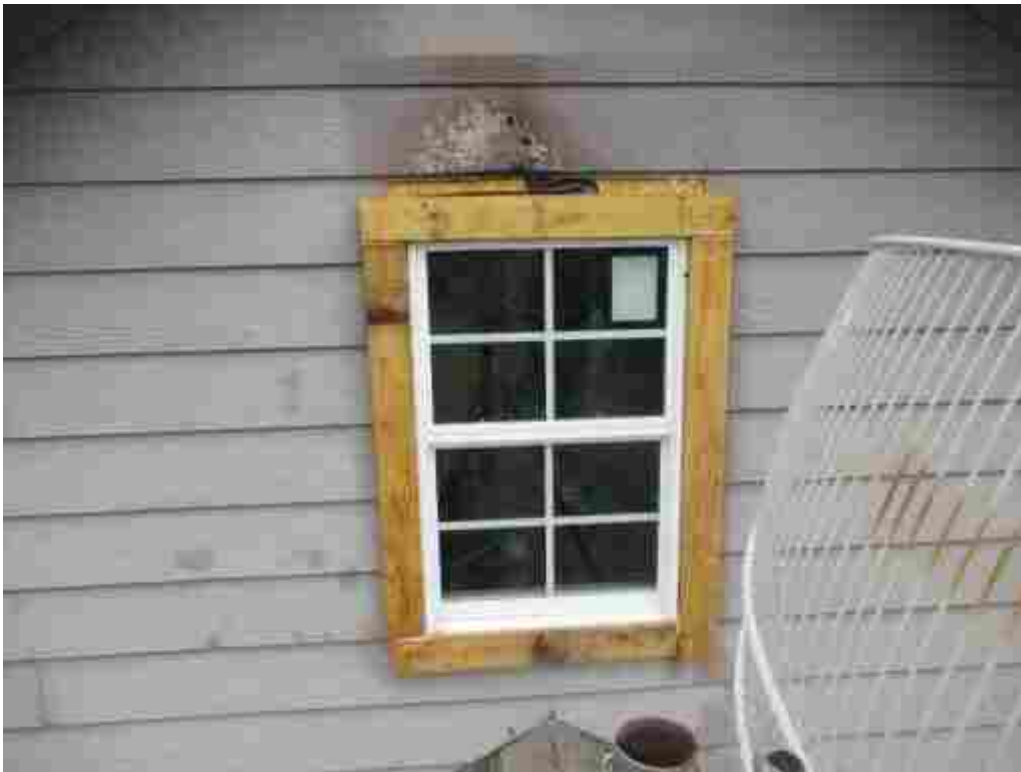
The exterior side of the new window in the Attic 2 gable. The siding was not replaced.

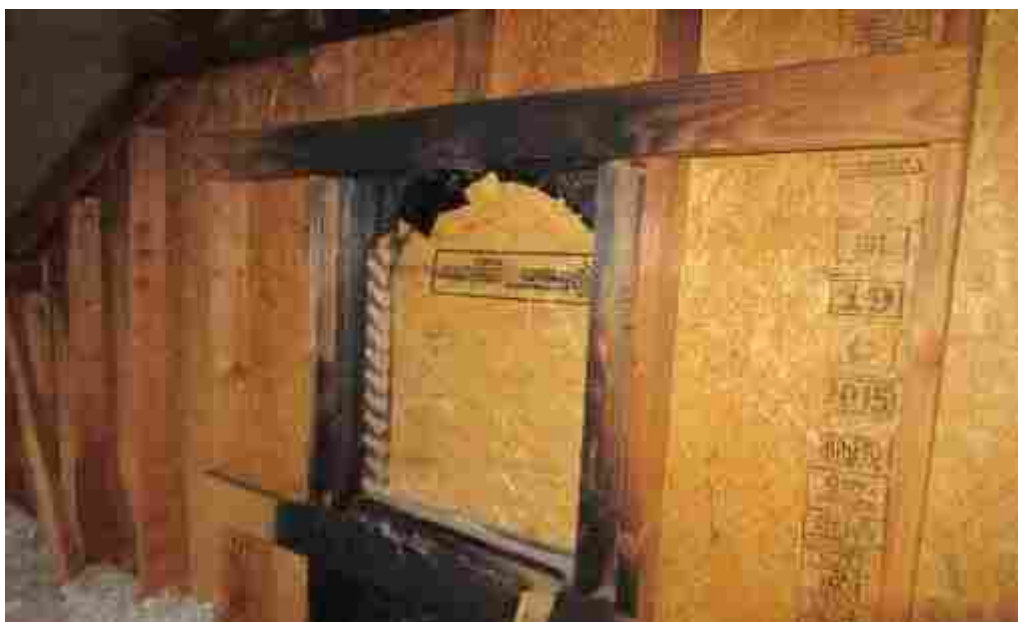
The fire damage is limited to the window framing and the portions of the studwall just below the window. It would not be necessary to replace the entire wall, measuring approximately 32' wide, to repair this damage.

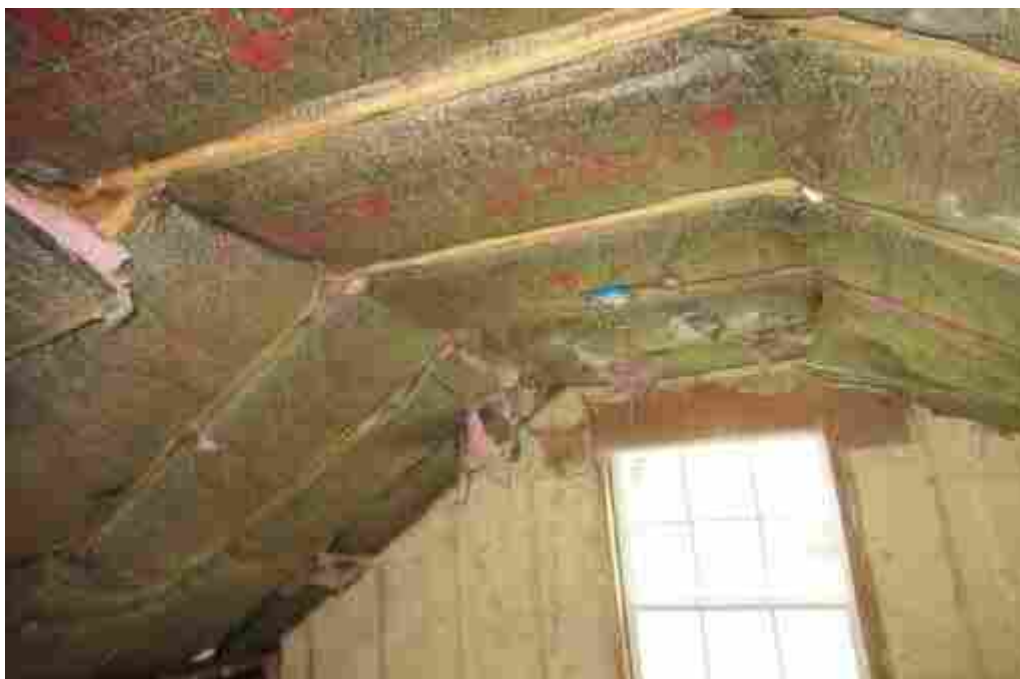
The commentary within the caption reflects the concerns expressed by Valor Forensic Engineering Services, LLC that fire damage to the wood framing had extended above the northwest garage.

The south sloped ceiling of the Theater Room is on the left. The fire spread from the area of the attic farther to the left of this photo. This photo shows the fire was blocked at the short wall of the Theater Room and contained within the attic space. It would not be necessary to replace all this framing and additional framing to the right of the photo as Williams seems to recommend.
